# HEALTH AND SAFETY RISK ASSESSMENT

**Carmichael Court**

**Grove Road  
London  
SW13 0HA**

**Farrar Property Management**  
**Date of assessment: 14/01/2013**  
**Recommended review date: January 2015**

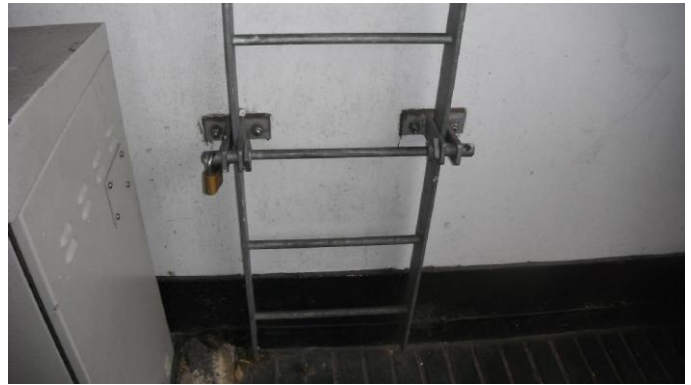
Roof access

<b>Hazard reference:</b>	3.WH				
<b>Hazard location(s):</b>	Access to roof.				
<b>Hazard description:</b>	Access ladders to upper level are above 2m in height and are not fitted with suitable safety hoops or permanently fixed fall arrest systems. Fall hazard.				
<b>Sources of fuel:</b>	N/A				
<b>Sources of ignition:</b>	N/A				
<b>People at risk:</b>					
Contractors	Employees	Public	Others	Tenants	Visitors
1-2					
<b>Existing controls:</b>	Access to ladders controlled.				
<b>Risk Evaluation:</b>	Severity	Likelihood	Risk Rating	Priority	
	3	1	3	3	
<b>Action required:</b>	Install safety hoops on ladders, which are at intervals of not more than 900mm measured along the stiles, and which commence at a height of 2.5m above the base of the ladders, in accordance BS5395-3:1985.				
<b>Result of action:</b>	When the above action has been implemented, the risk rating will be: <b>Reduced</b>				
<b>Monitoring and ongoing requirements:</b>	Ensure fixed ladders are maintained in good condition.

Secured access ladder

3.WH	<p>Access to roof. Access ladders to upper level are above 2m in height and are not fitted with suitable safety hoops or permanently fixed fall arrest systems. Fall hazard.</p>	<p>Install safety hoops on ladders, which are at intervals of not more than 900mm measured along the stiles, and which commence at a height of 2.5m above the base of the ladders, in accordance BS5395-3:1985.</p>
	<p><b>Action taken by:</b></p> <p><b>Date:</b></p>	<p><b>Comments:</b></p>
